# RESTORATION GUIDE

## SEALANTS

# SEALANTS

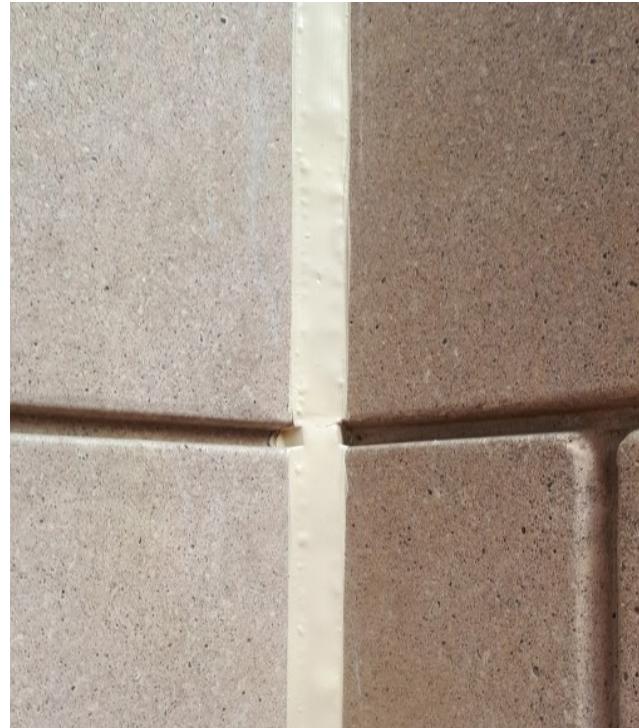
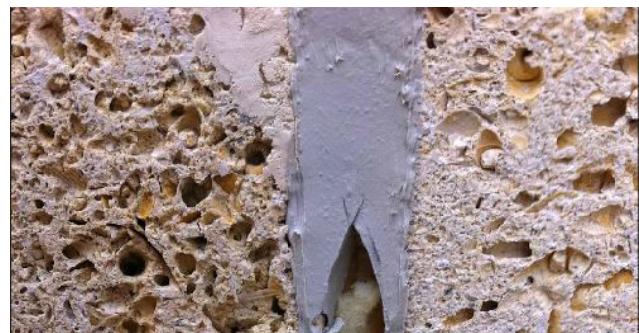
Presenting as small bumps or blisters on the surface of sealant bead, blistering is usually caused either by unwanted moisture in the substrate behind the sealant bead or by holes punched into the closed cell backer rod during application.

### Method A – Punctured Closed-Cell Backer Rod:

1. Remove the blistered sealant with a sharp knife, extending the cuts 2 to 3 in. [5 to 8 cm] beyond the affected area.
2. Remove the perforated section of the backer rod with a sharp knife.
3. Replace the backer rod with a new section of backer rod, ensuring that no holes are made in the new material.

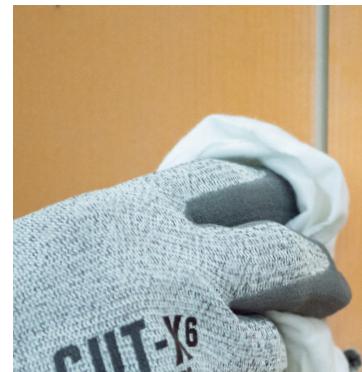
4. Clean the sides of the substrate using isopropyl alcohol (IPA) or similar cleaner, employing the “Two-Cloth” method.<sup>1</sup> Allow to dry completely.
5. Reinstall sealant according to the manufacturer’s instructions.
6. Be sure to tool the sealant to make sure that there is no void between the new and existing sealants.

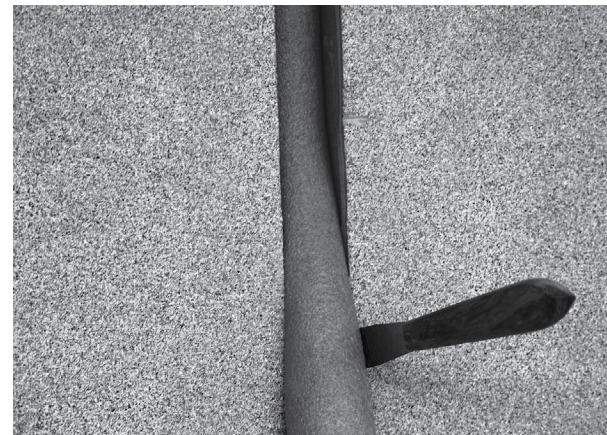
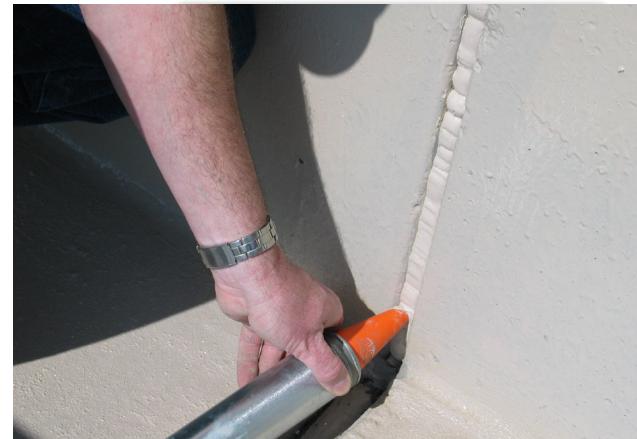
**Method B – If Moisture Is an Issue:**

1. Remove the blistered sealant with a sharp knife, extending the cuts at least 6 in. (15 cm) beyond the affected area.
2. If an open-cell backer rod is wet, it should be replaced.
3. Allow to dry, either naturally or with fans/blowers.
4. Clean the sides of the substrate using isopropyl alcohol (IPA) or similar cleaner, employing the “Two-Cloth” method.<sup>1</sup> Allow to dry completely.
5. Reinstall sealant according to manufacturer’s installation instructions.
6. Be sure to tool the sealant to make sure that there is no void between the new and existing sealants.

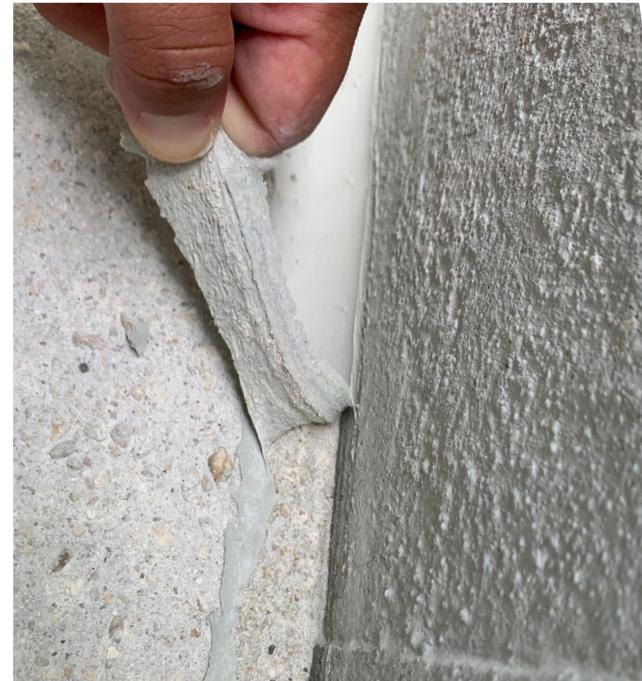
If you observe gaps between the sealant bead and the substrate or the sealant bead is missing entirely, you could have moisture intrusion and/or adhesion issues. Moisture may have been introduced inadvertently during the sealant tooling process, or the sealant may have been installed without the primer required for that substrate.

- Tools were cleaned with water, instead of xylene or similar cleaners.
- Sealant was applied over a moist substrate due to adverse weather.
- The original substrates were not cleaned properly or had loose debris.
- A pull test or mockup to verify adhesion between the substrate and sealant was not done.
- A pull test was conducted, and the tested area was not repaired afterward.

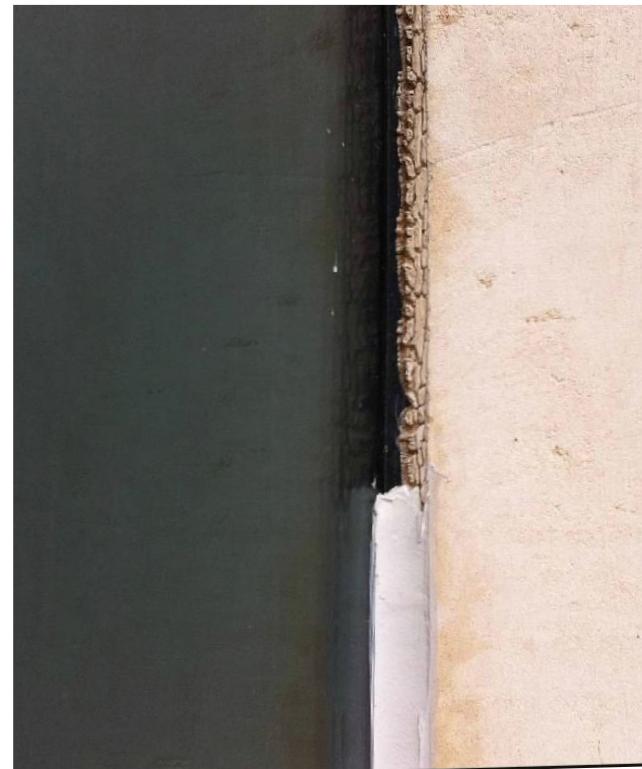
To identify the source of the issue and its proper repair, examine the affected area for the following:

If debris or rust is pulled out with the sealant, see **Method A** as this may mean the substrate was not cleaned properly before sealant application. If traces of a previous sealant are found on the substrate, reference **Method B**, as this can point to compatibility issues between the existing sealants. See **Method C** if the sealant is pulled cleanly away from the substrate, as this means that a primer may be needed for better adhesion. If sealant is missing from the joint altogether, see **Method D**.

Prior to any repair, conduct a pull test<sup>2</sup> of the affected sealant, if any, according to ASTM standards to review for adhesion and determine if a primer is needed. A sample of the existing sealant can be sent to Tremco CPG technical services for additional insight.

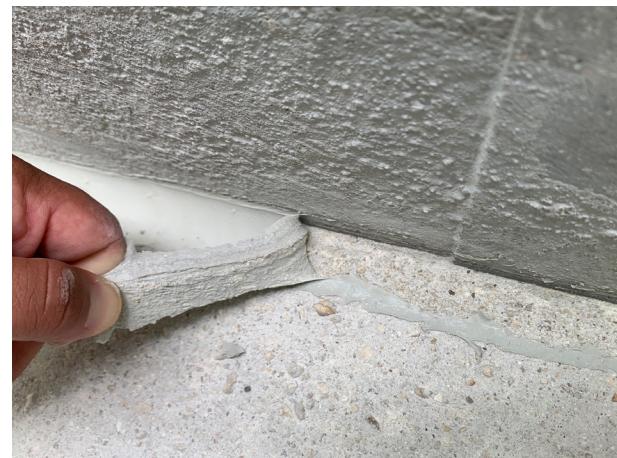
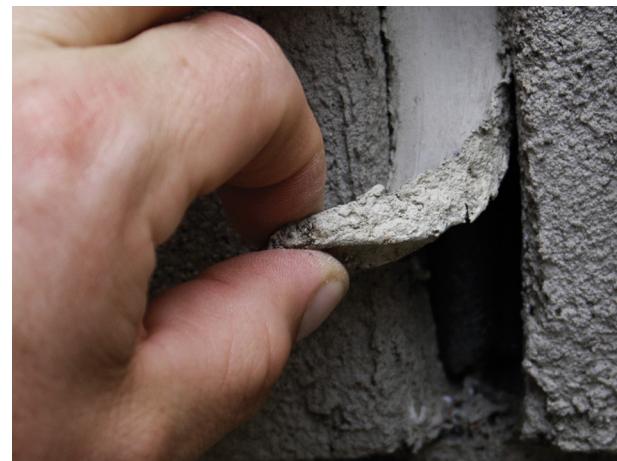
#### **Method A – If Debris or Rust Is Pulled out with the Sealant:**

1. Remove the affected sealant with a sharp knife extending the cuts 6 to 12 in. (15 to 30 cm) beyond the affected area. Use a grinder if necessary.
2. Grind the surface properly making sure there is no more debris. If rust is present, sandblast until rust is removed.
3. Clean the sides of the substrate using isopropyl alcohol (IPA) or similar cleaner, employing the “Two-Cloth” method.<sup>1</sup> Allow to dry completely.
4. Reinstall sealant according to the manufacturer’s installation instructions.
5. Be sure to tool the sealant to make sure that there is no void between the new and existing sealants.

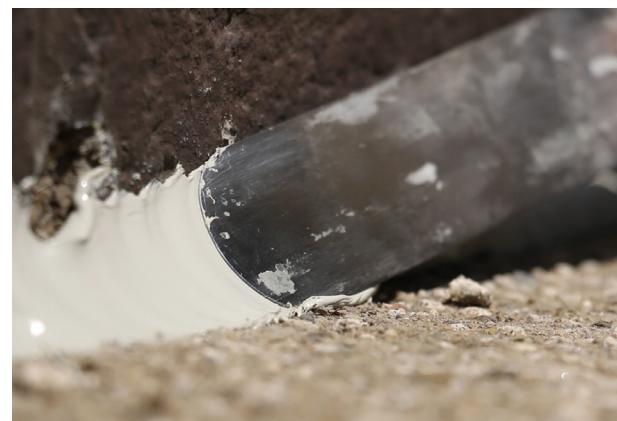
#### **Method B – If Traces of Previous Sealant Are Found on the Substrate:**

1. Remove the affected sealant with a sharp knife, extending the cuts at least 6 to 12 in. (15 to 30 cm) beyond the area. Use a grinder if necessary.
2. Clean the sides of the substrate using isopropyl alcohol (IPA) or similar cleaner, employing the “Two-Cloth” method.<sup>1</sup> Allow to dry completely.
3. Install new, compatible sealant according to manufacturer’s installation instructions.
4. Be sure to tool the sealant to make sure that there is no void between the new and existing sealants.

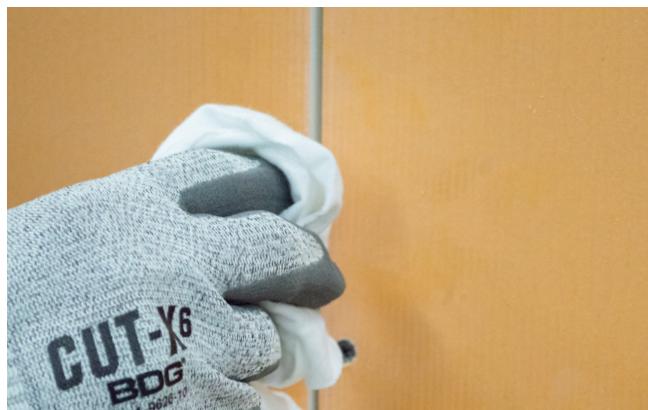
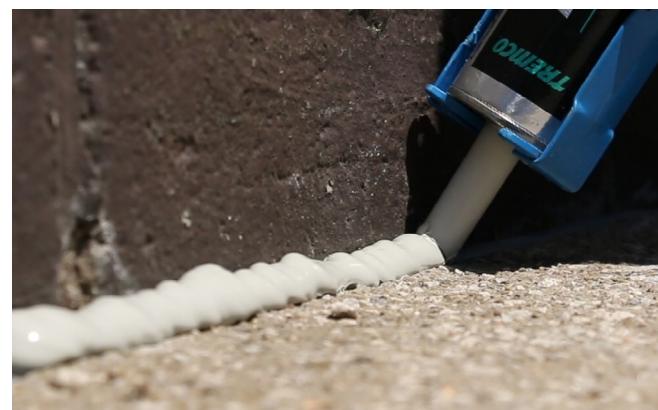
### **Method D – If Sealant Is Missing from the Joint:**

1. Clean the sides of the substrate using isopropyl alcohol (IPA) or similar cleaner, employing the “Two-Cloth” method.<sup>1</sup> Allow to dry completely.
2. Install sealant according to the manufacturer’s installation instructions.
3. Be sure to tool the sealant to make sure that there is no void between the new sealant and the existing sealant.

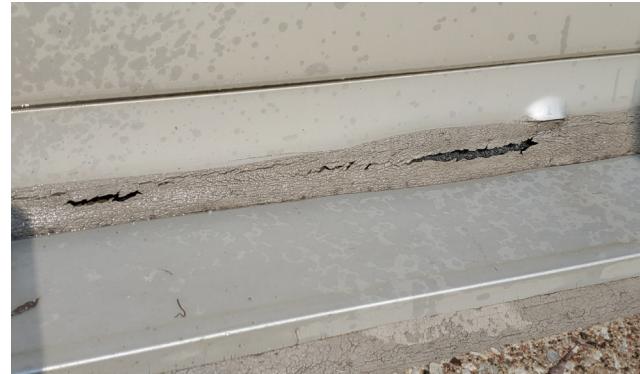
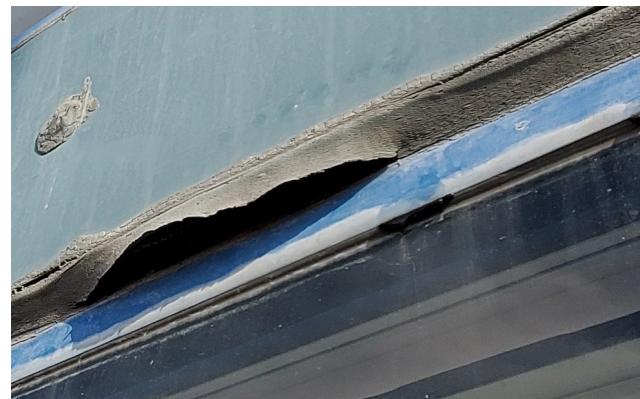
Identify cases of split sealant by observing a gap between the sealant bead and the substrate. This can be caused by poor surface preparation, a lack of proper maintenance or improper product selection.

- The sealant was installed over an unclean surface with surface debris, rust, etc.
- The sealant is not compatible with surrounding products or substrates.
- The sealant was not approved for prolonged UV exposure.
- The wrong material was specified for the job.

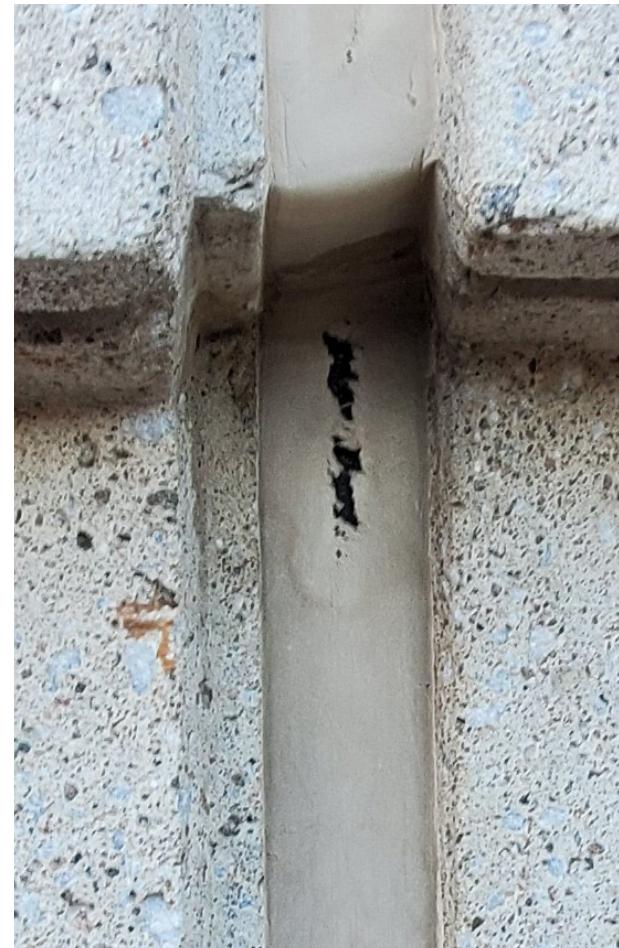
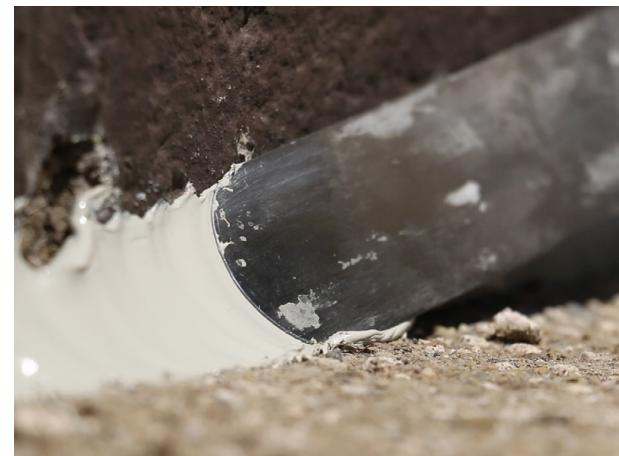
### **Method C – If the Sealant is Splitting Along the Joint:**

1. Remove the affected sealant with a sharp knife extending the cuts at least 6 to 12 in. (15 to 30 cm) beyond the affected area. Use a grinder if necessary.
2. Review the sealant and the substrate closely to make sure the substrate was clean, and no evidence of a previous sealant remains.
3. If none is found, then the joint movement should be reviewed either by consulting an engineer or by using a crack movement gauge.
4. When joint movement is determined, select an appropriate sealant material for the anticipated joint movement, and make sure it is within the material’s elongation parameters.
5. Remove the existing sealant bead completely and use a grinder, if necessary, to prepare the surface.
